To fix the problem of the phone powering on or staying on the welcome UI problem, please follow up the below procedures to solve the problem.

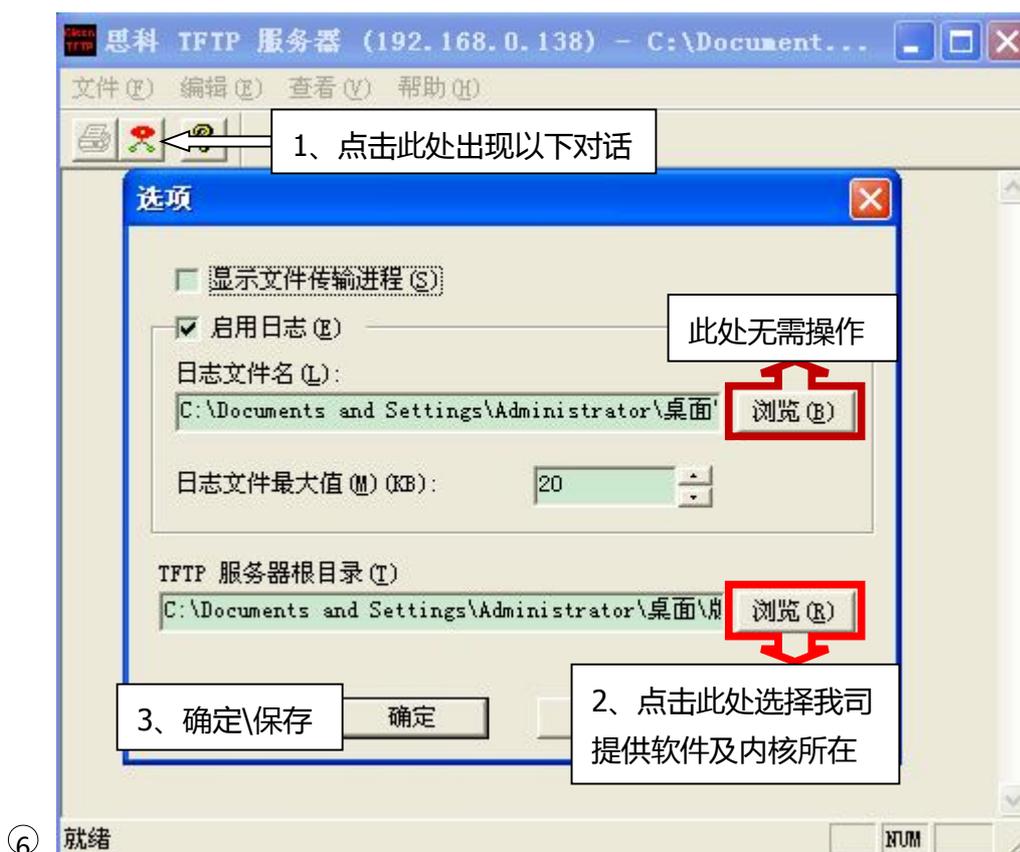
- ① 1 unit cable
- ② Set your PC with static IP :192.168.0.XX (Except 192.168.0.200), e.g. 192.168.0.138
- ③ Install TFTP software

- ④ prepare the attached software
- ⑤ Enable TFTP

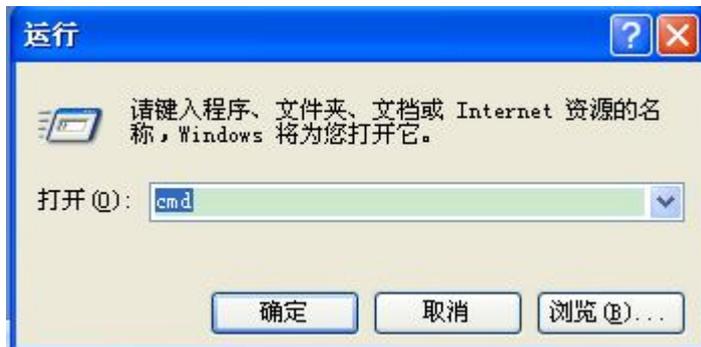
- 2、 After power on 2 mins, please connect PC and IP phone with cable
- 3、 Open DOS to run "cmd"

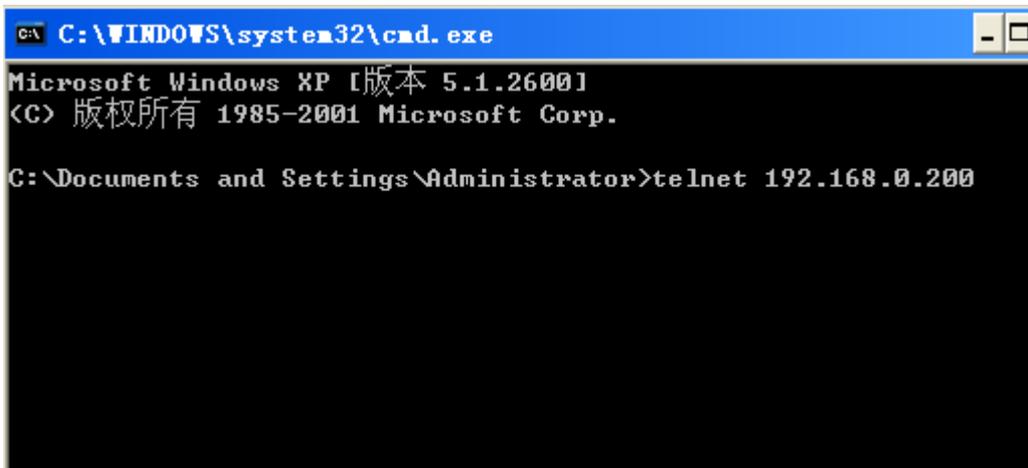
Input the command: **telnet 192.168.0.200**

After entering into telnet, user name and password both are "root".
